Photo Report of Koteles Garage

Site Inspection Date: 06/10/2020

Inspector: Nathan Marcus, E.I.T.

Prepared for: Levandosky v. Koteles Dispute

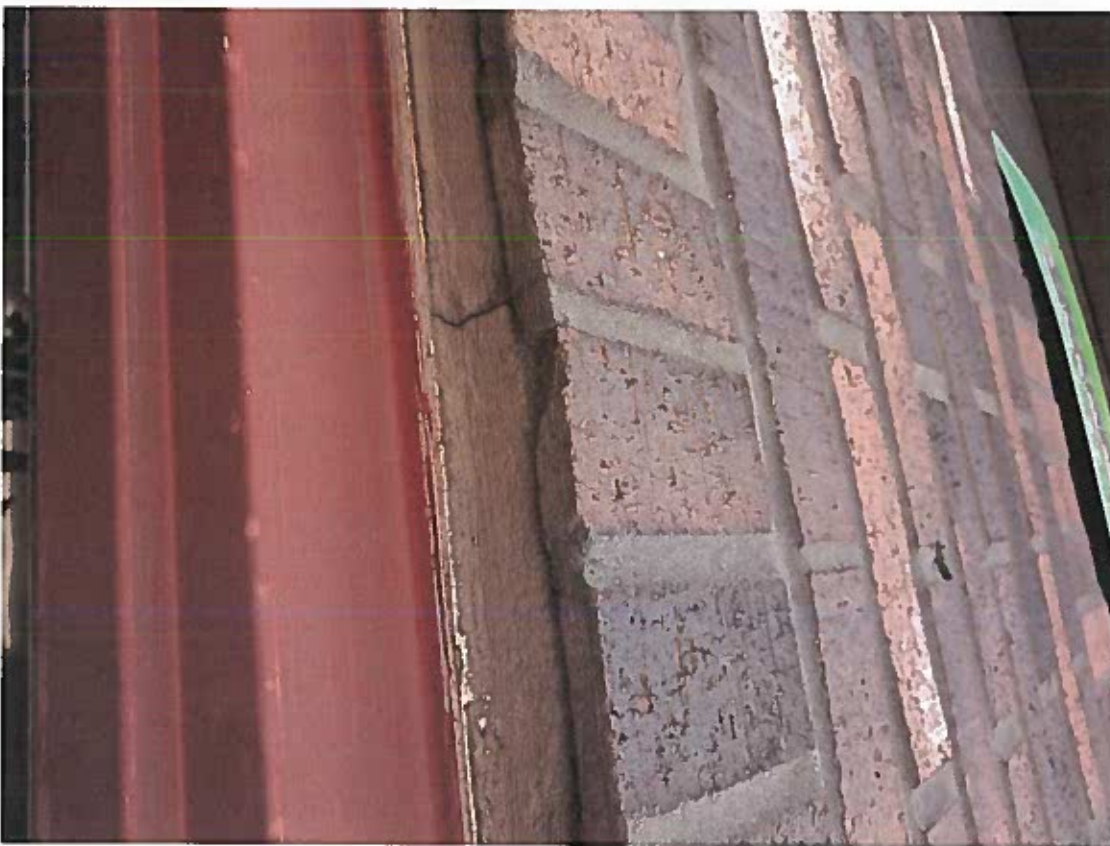
Cracking above the front entry door adjacent to the property's front garage bays.

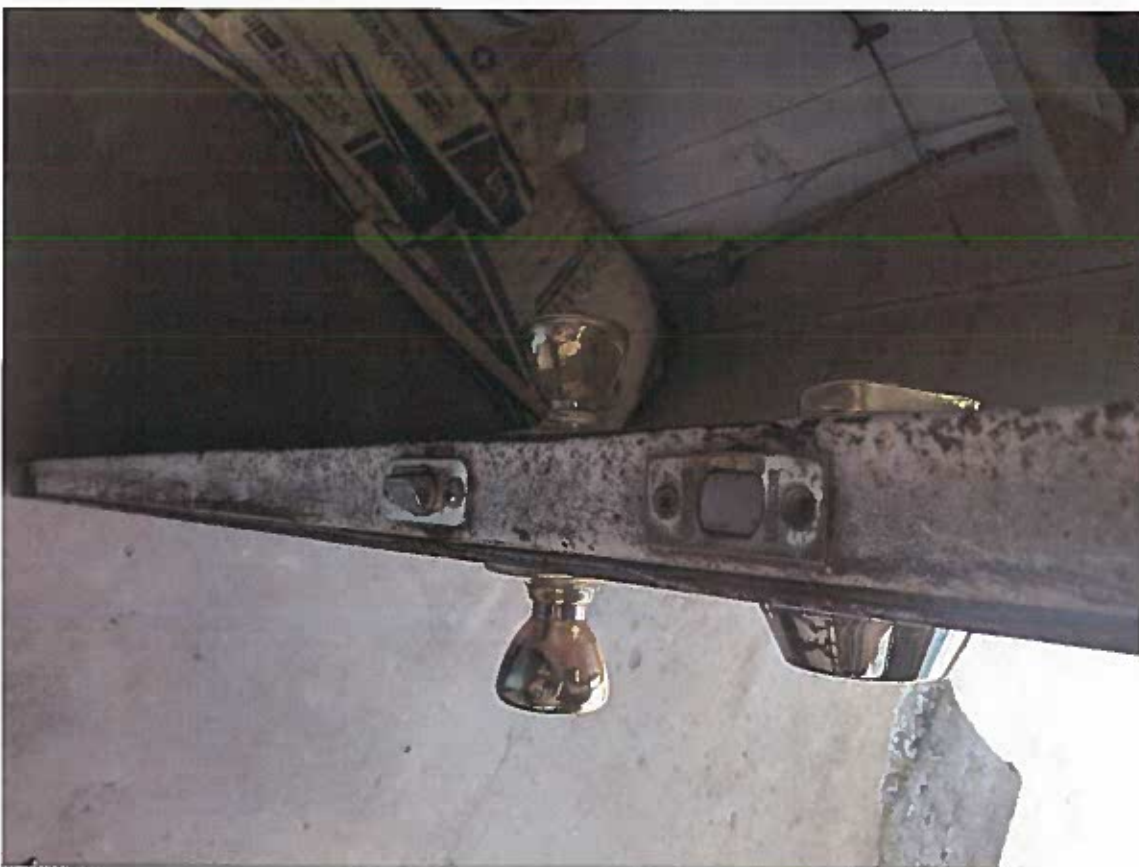
Extensive wear and tear on front entry door for customers. Rusty, needs repainted, damaged striker plate.

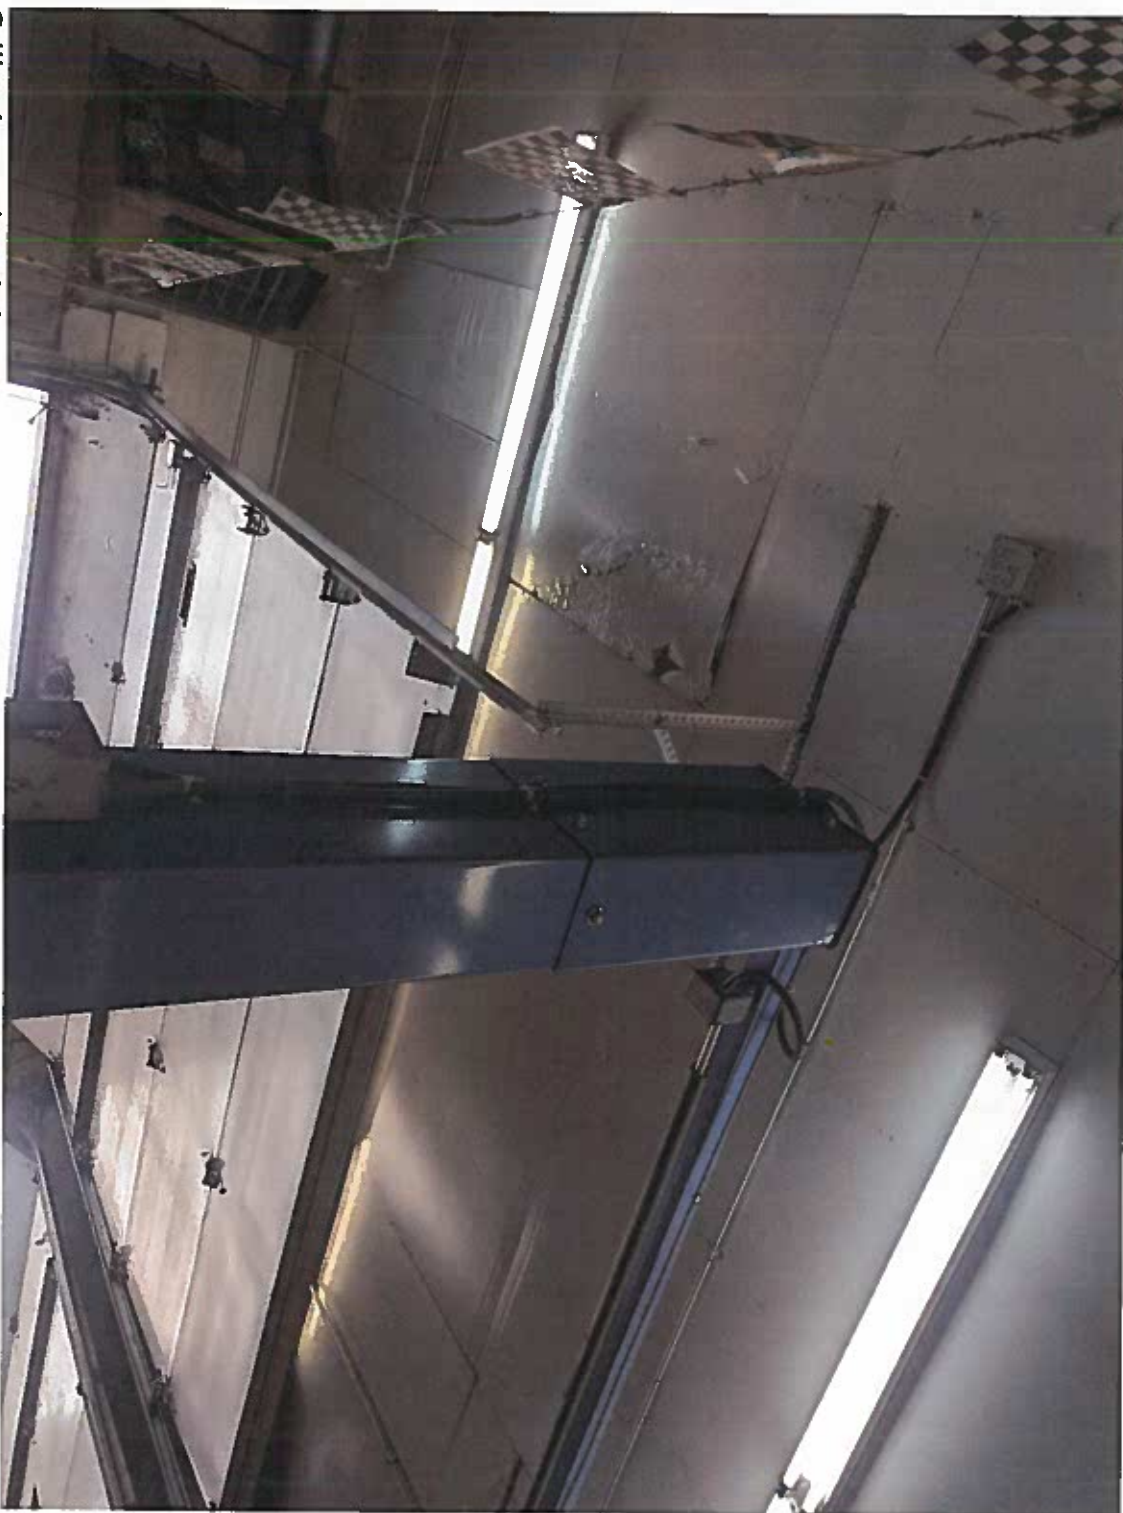
Ceiling damage in main bay area.

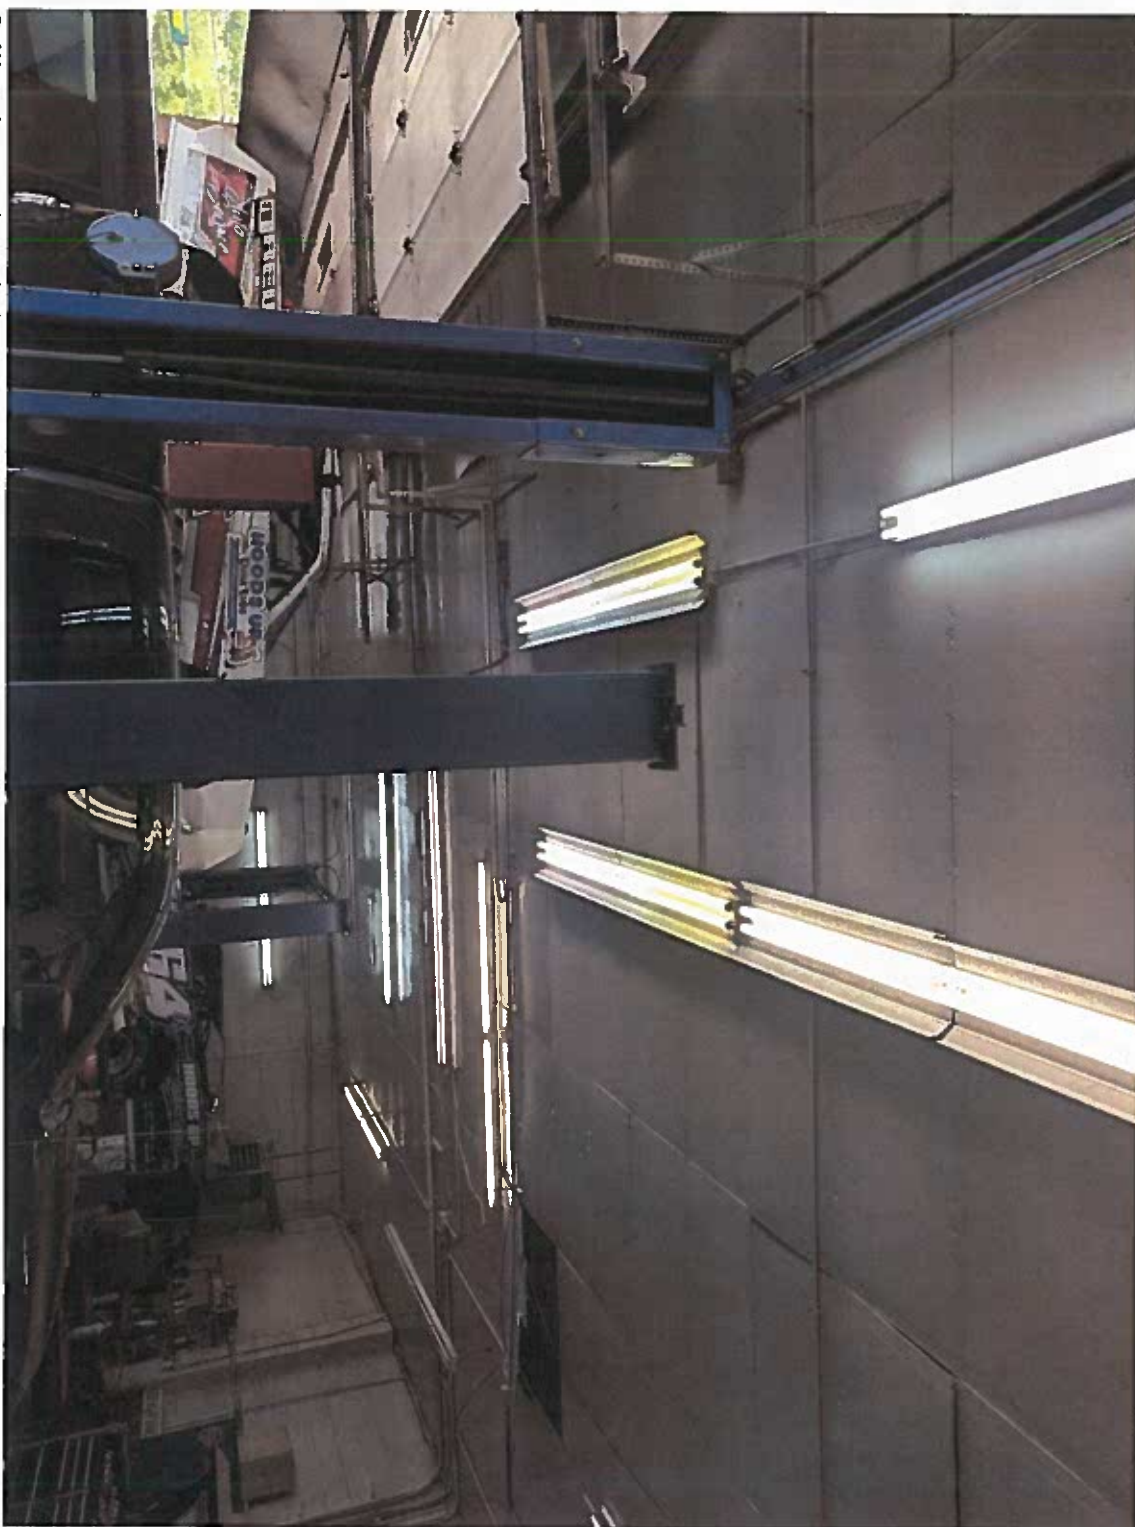
Ceiling damage in main bay area.

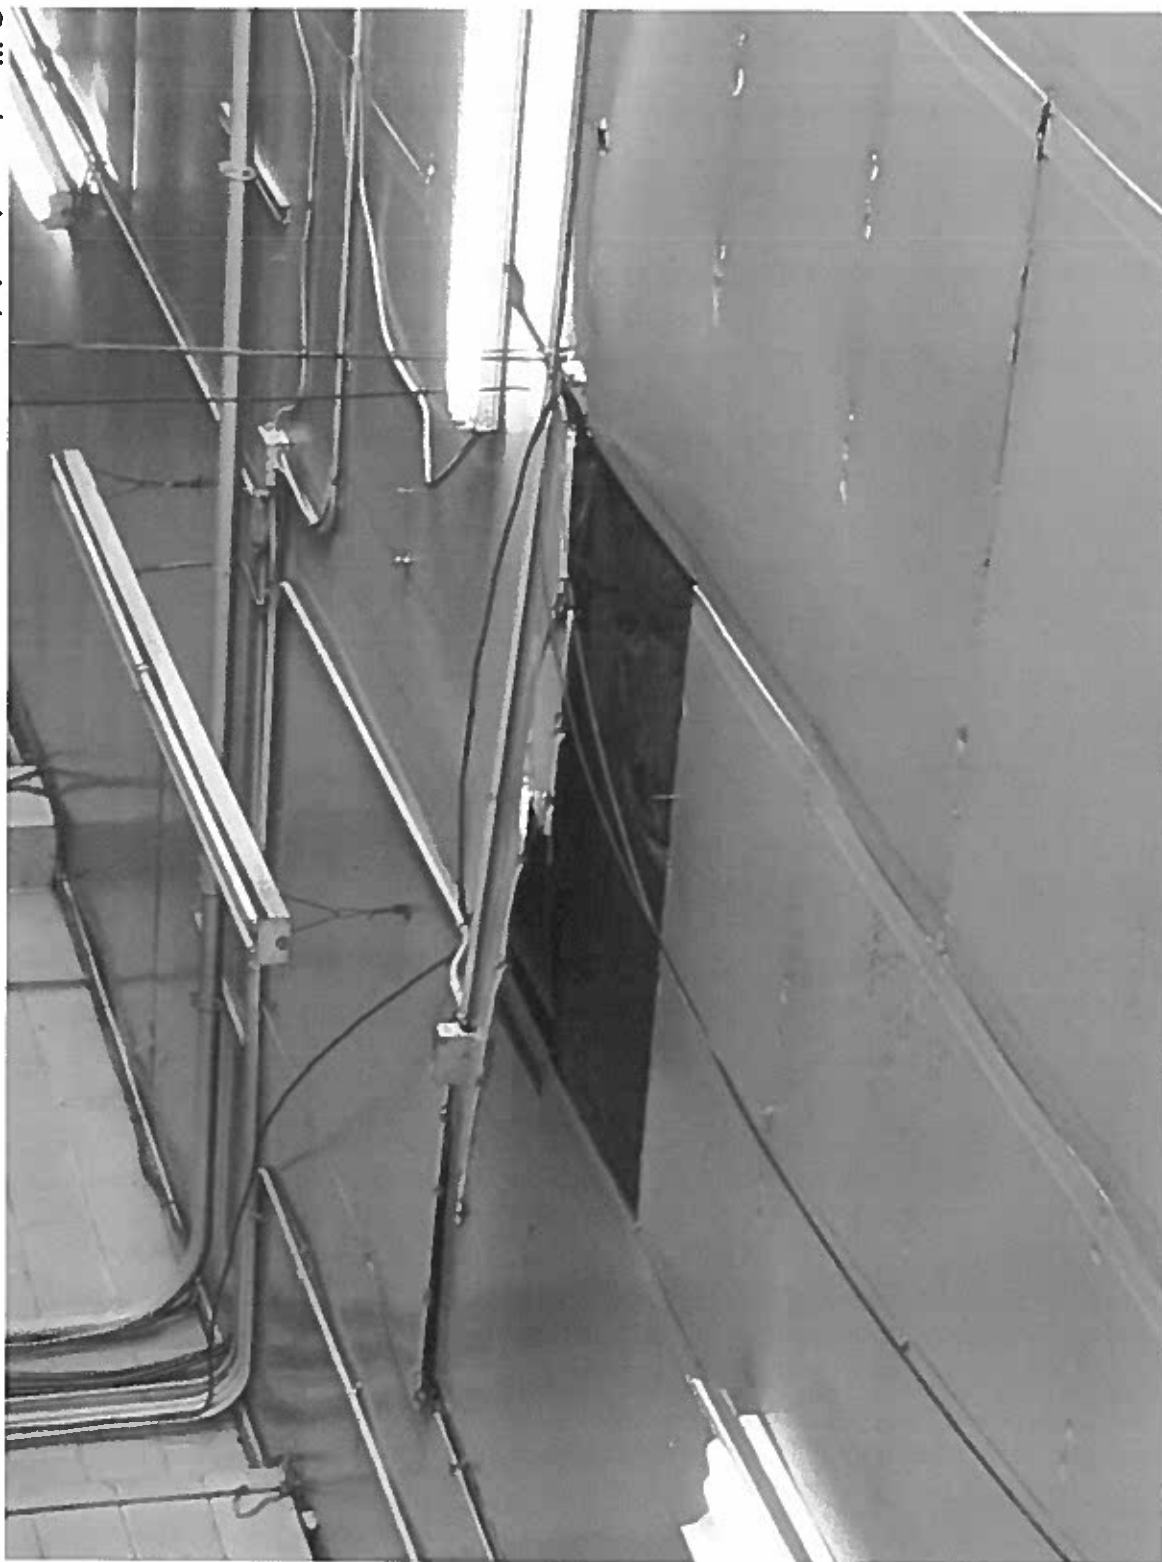
Ceiling damage in main bay area.

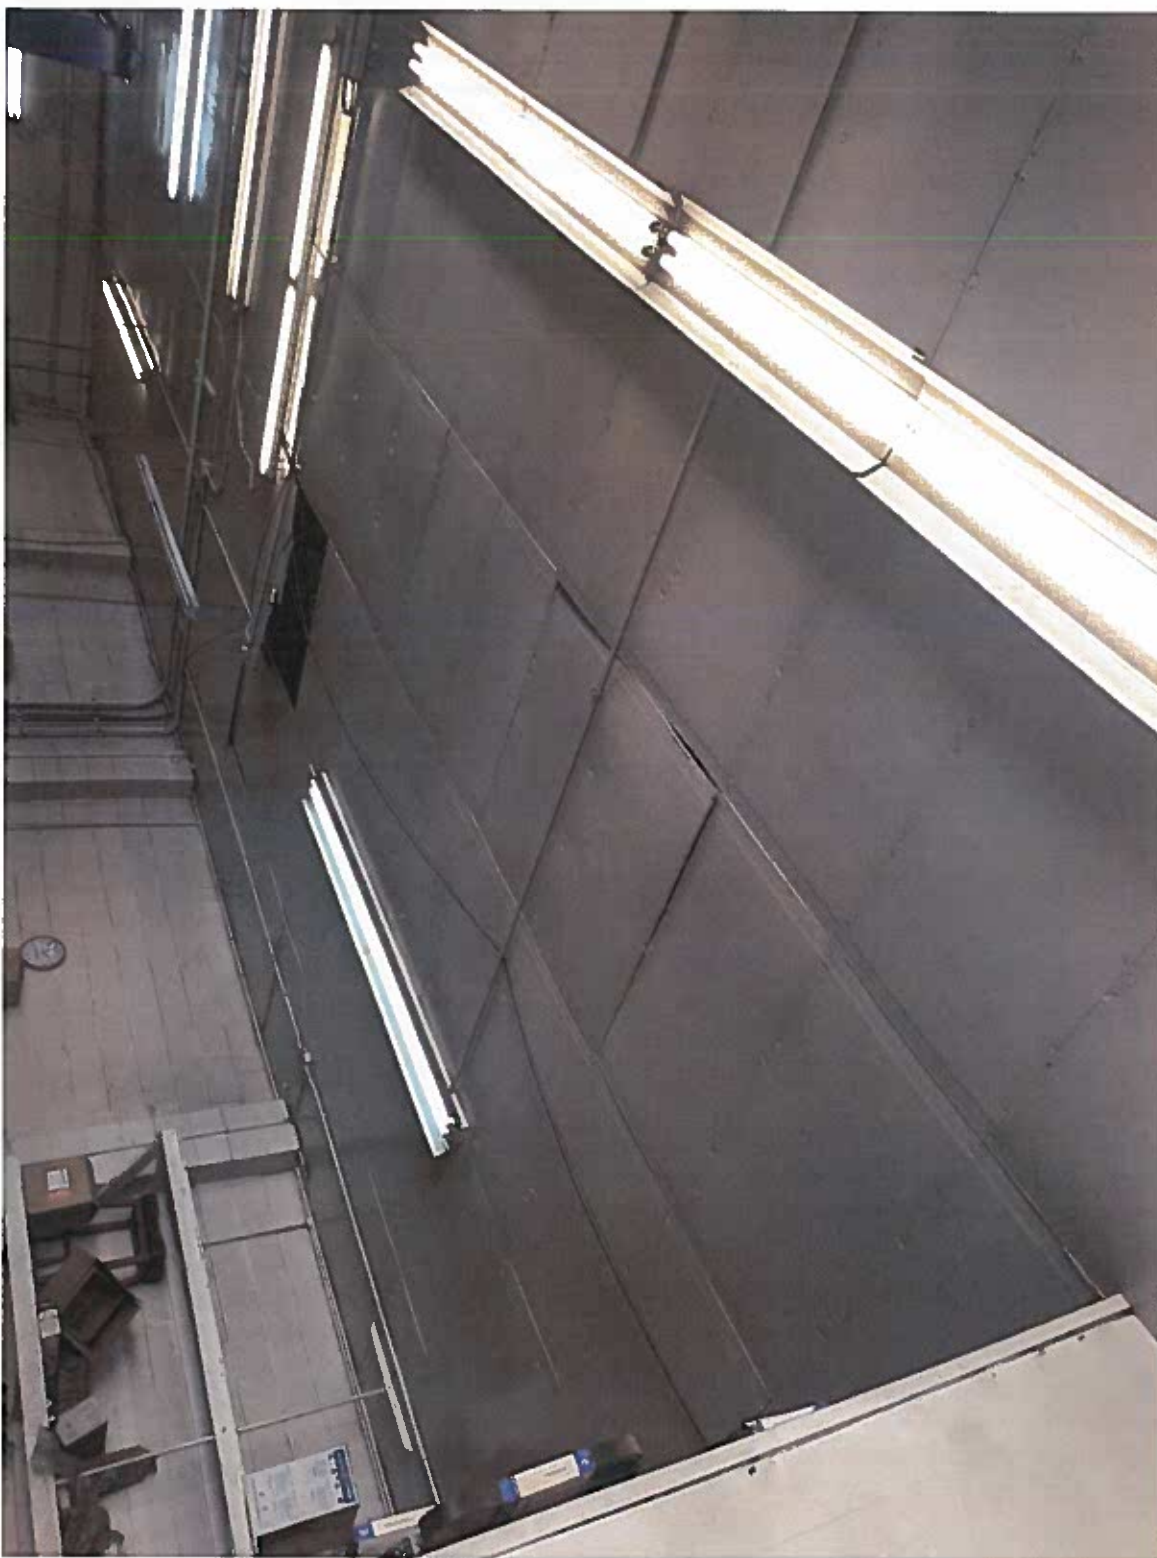
Ceiling damage in main bay area.

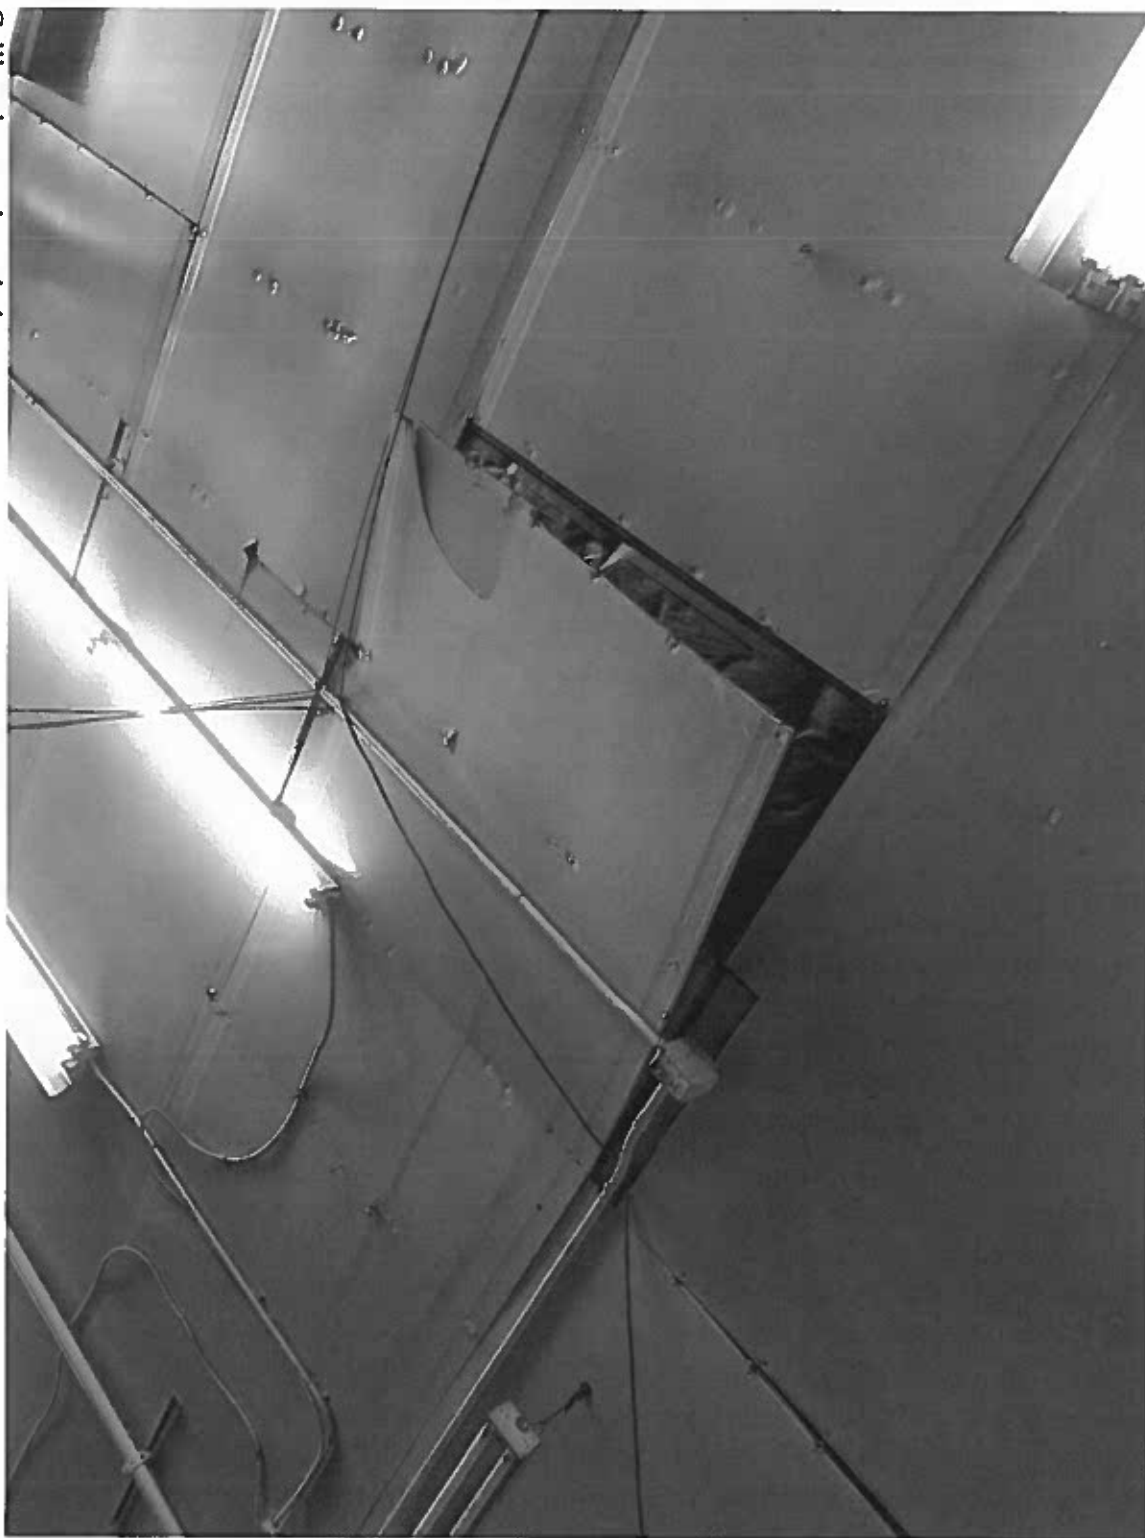
Ceiling damage in main bay area.

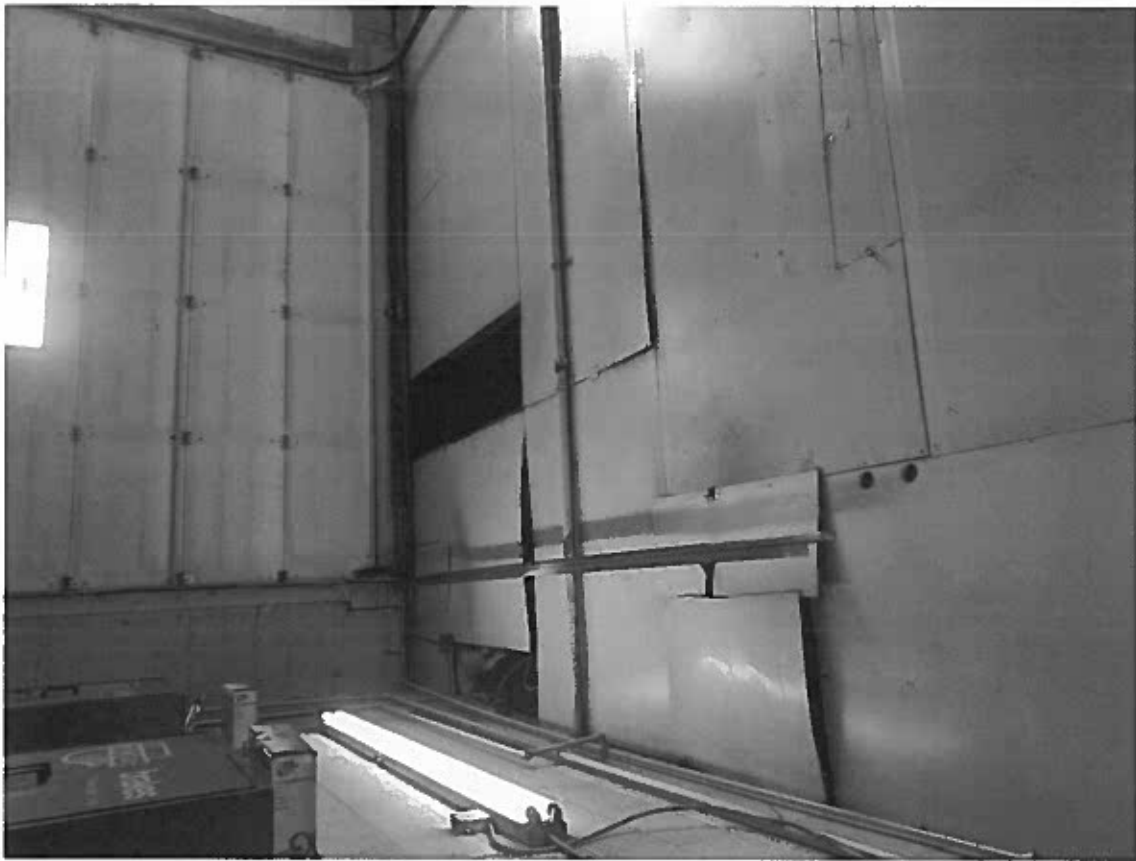
Ceiling damage in main bay area.

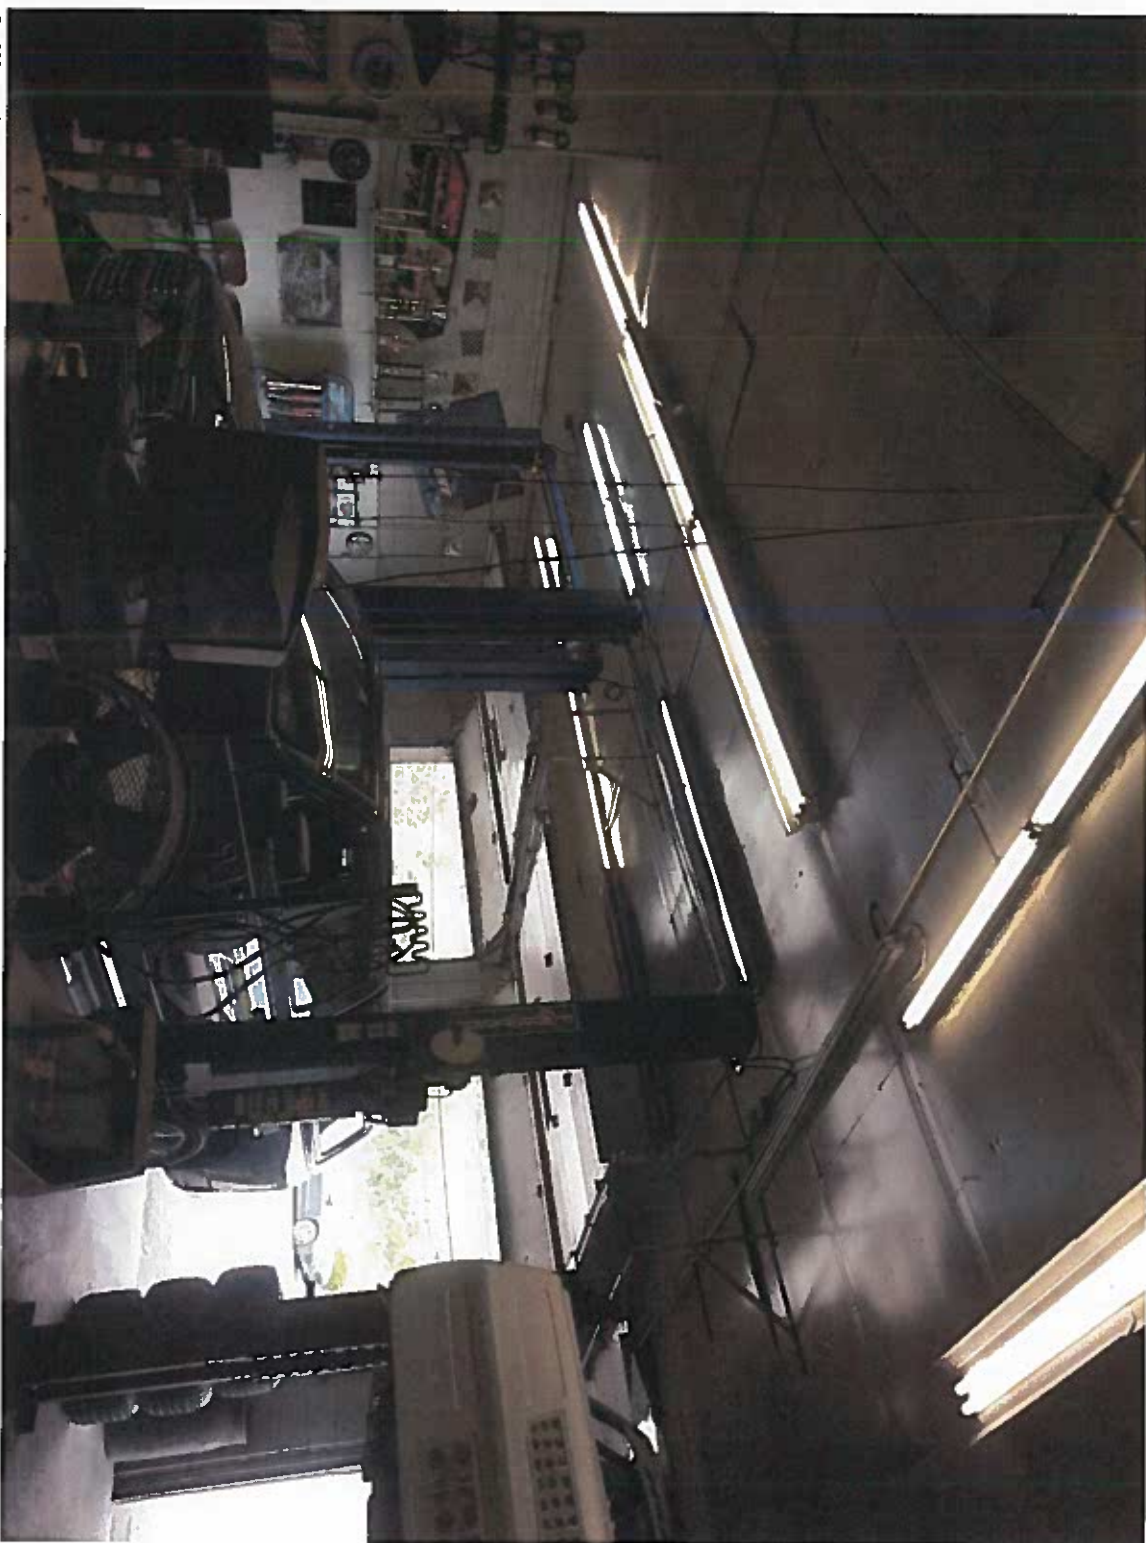
Ceiling damage in main bay area.

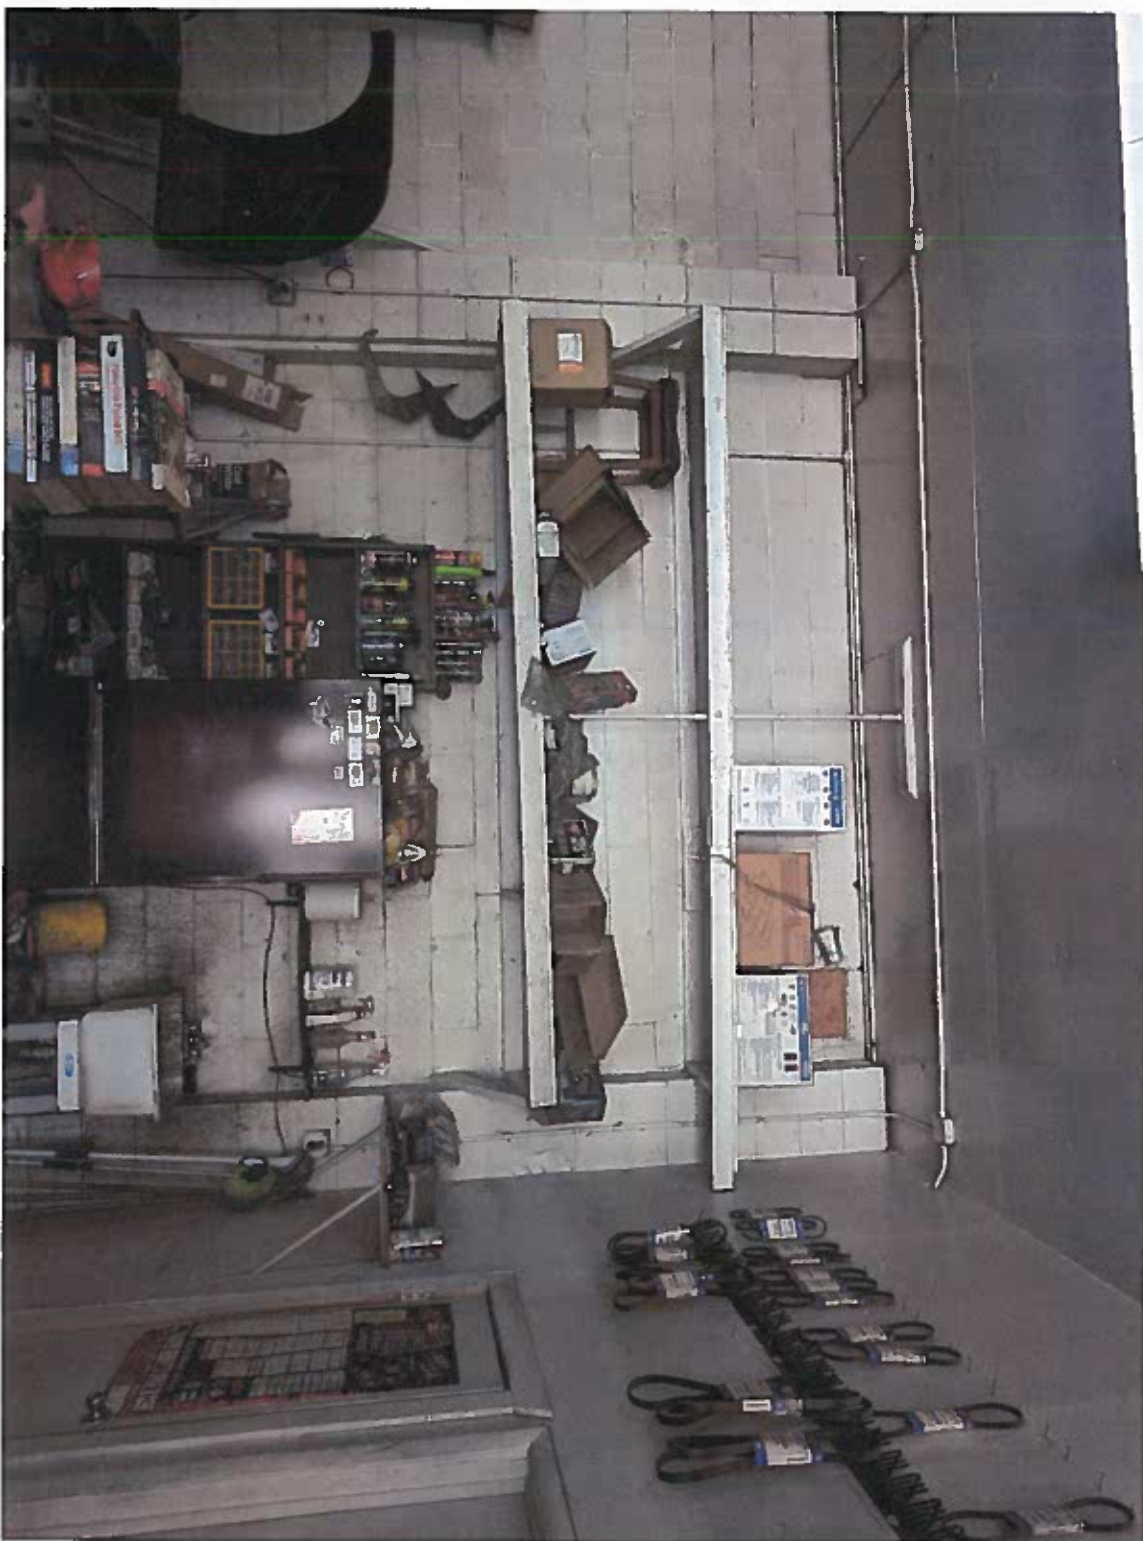
Crooked shelving. Previously overloaded?

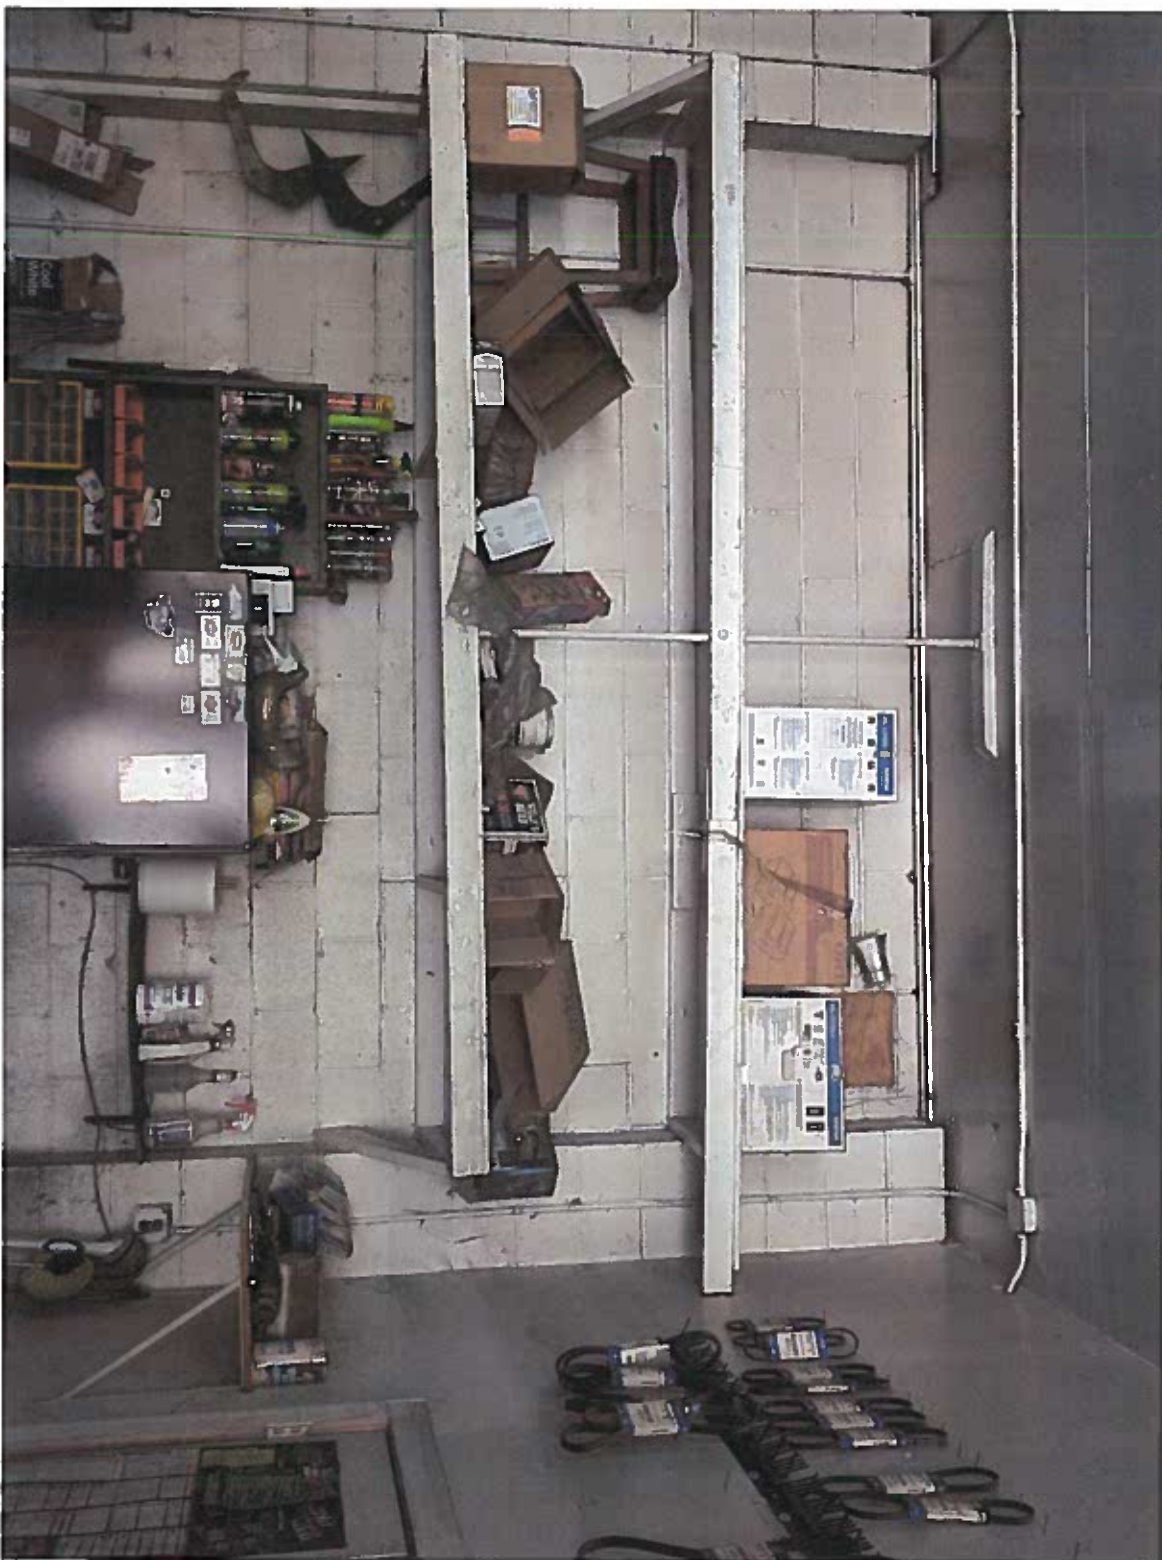
Crooked shelving. Previously overloaded?

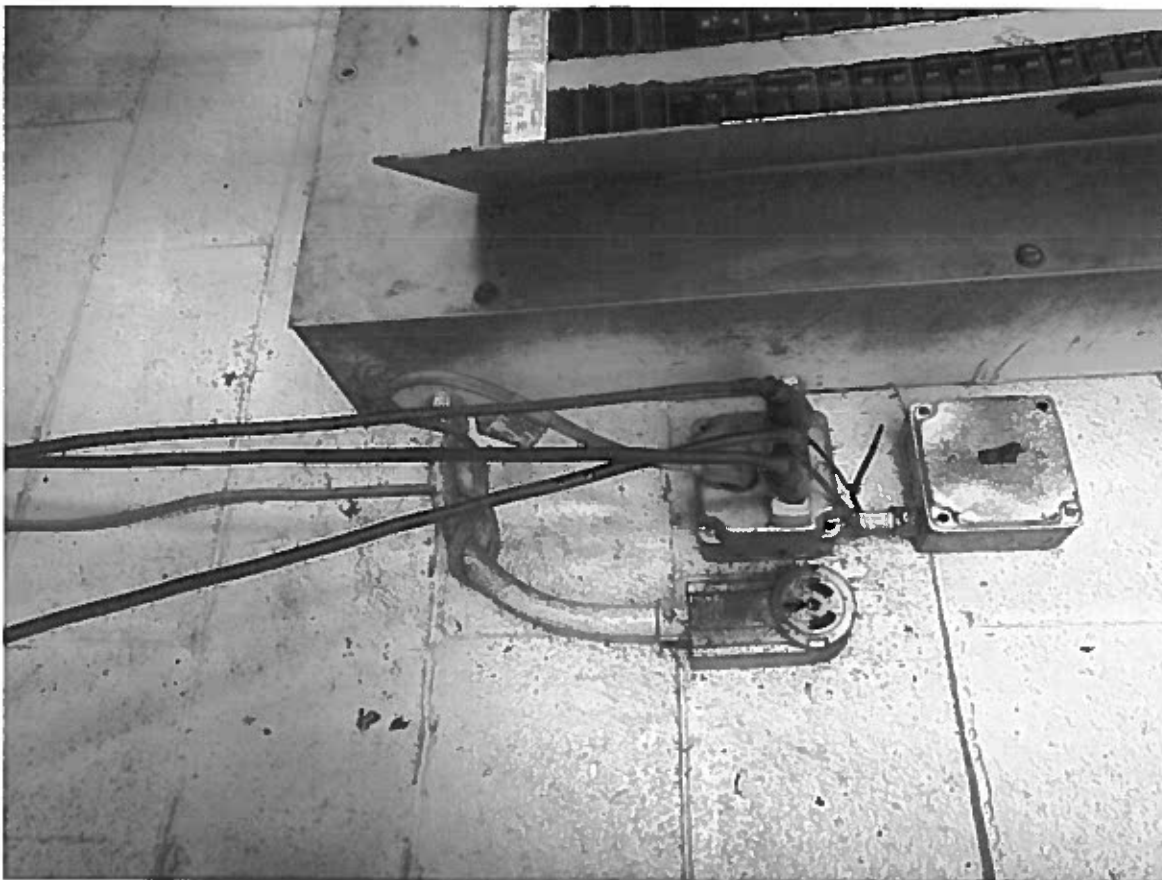
Highly loaded single circuit.

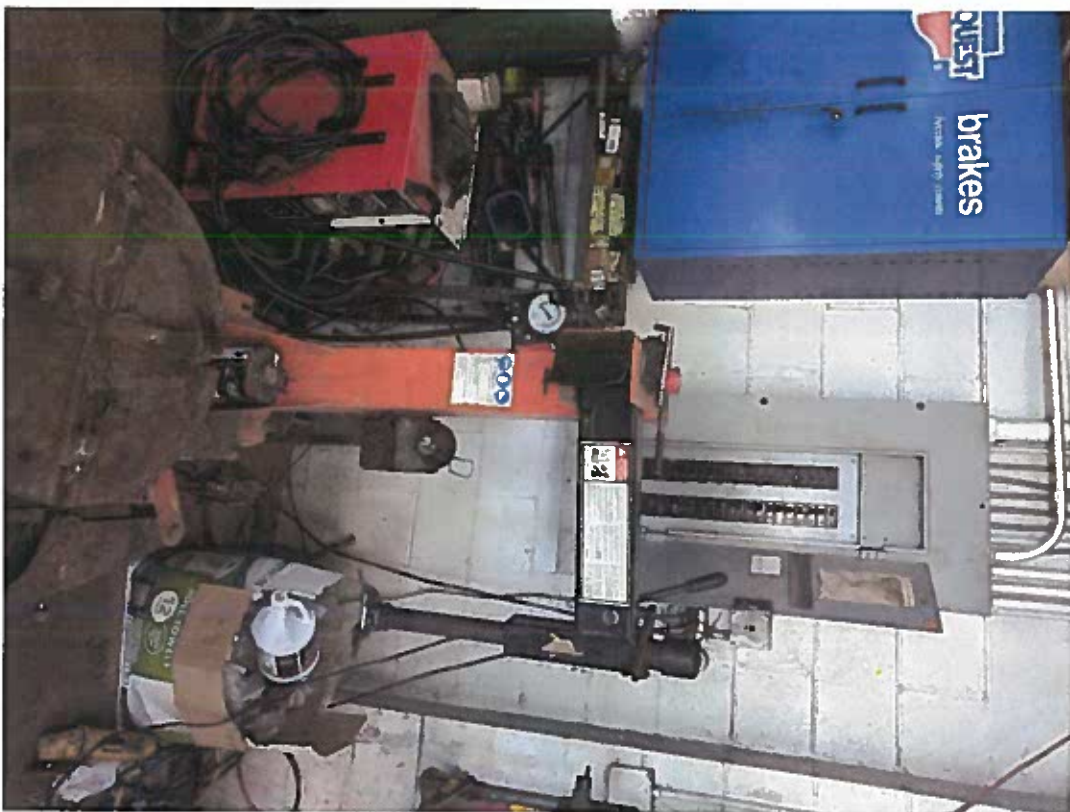
Highly loaded single circuit.

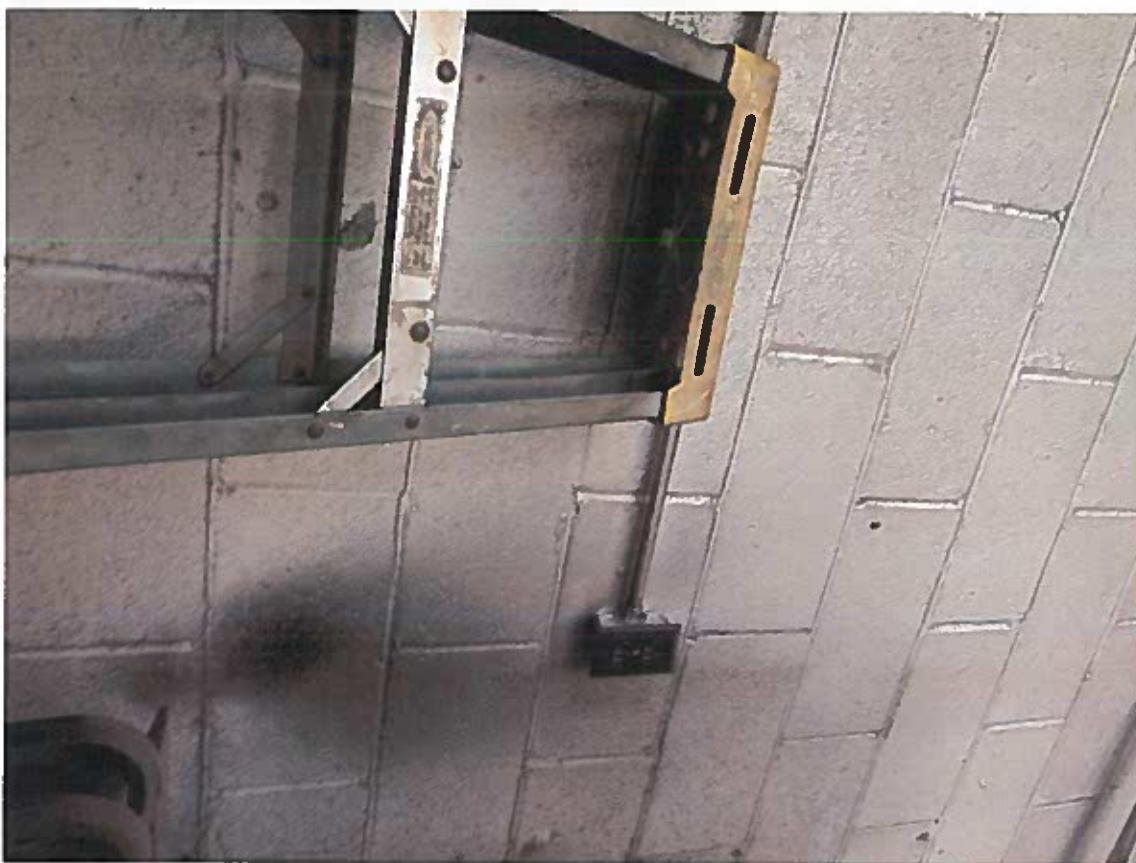
Burn mark or exhaust located on wall of the main bay.

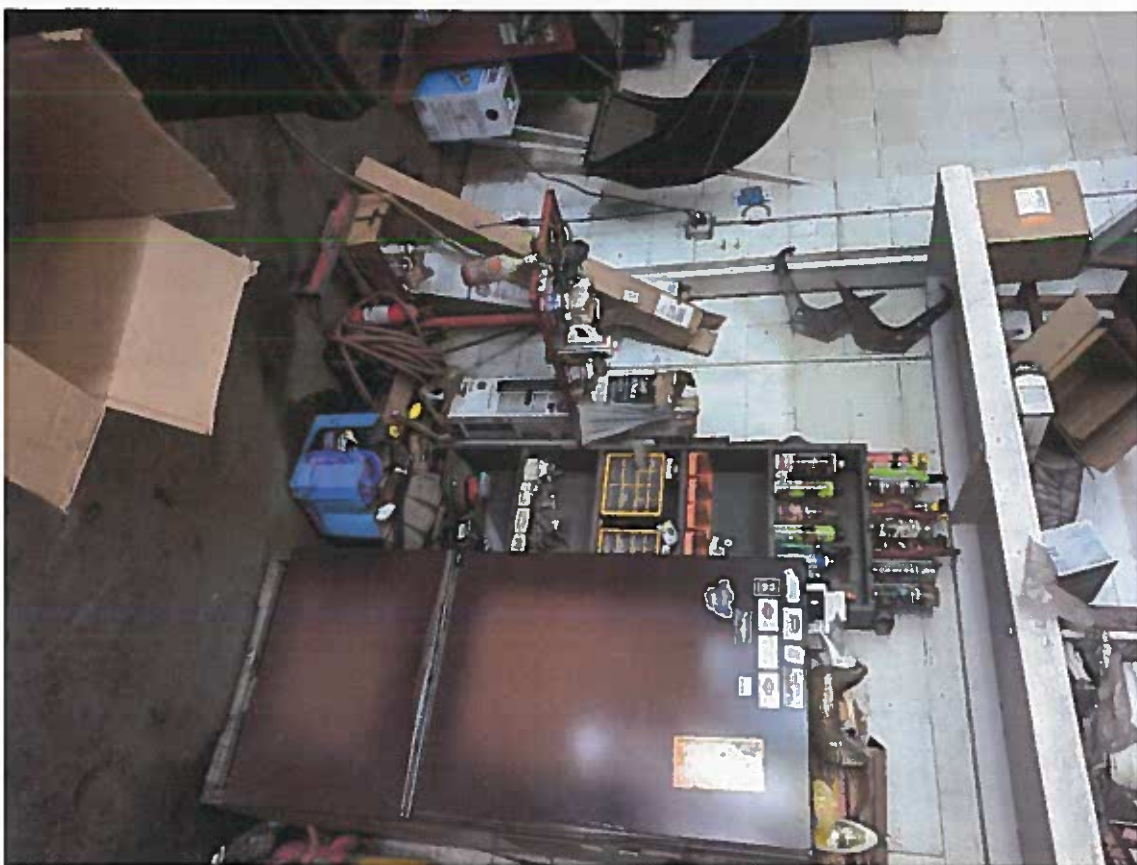
Only five extinguishers found in the main bay placed in misc equipment pile on floor. Extinguishers not clearly marked where located.

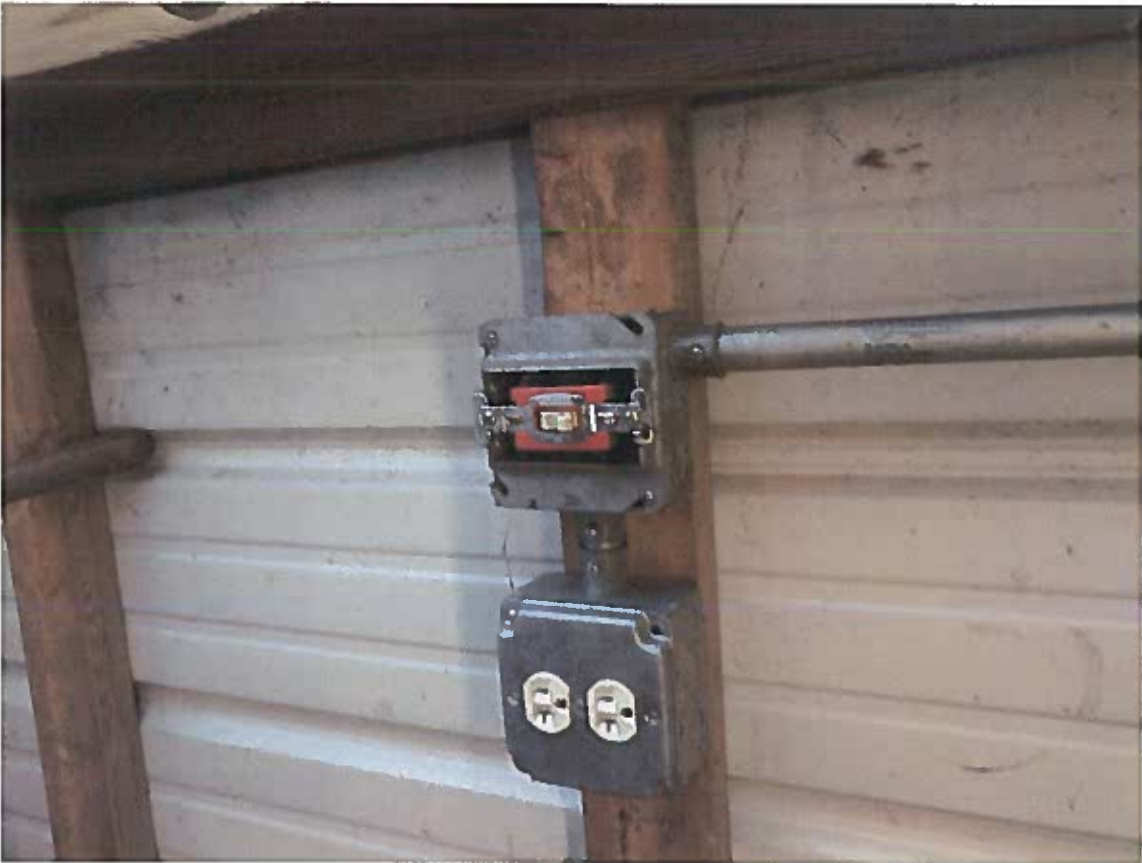
Missing light switch cover in rear white building.

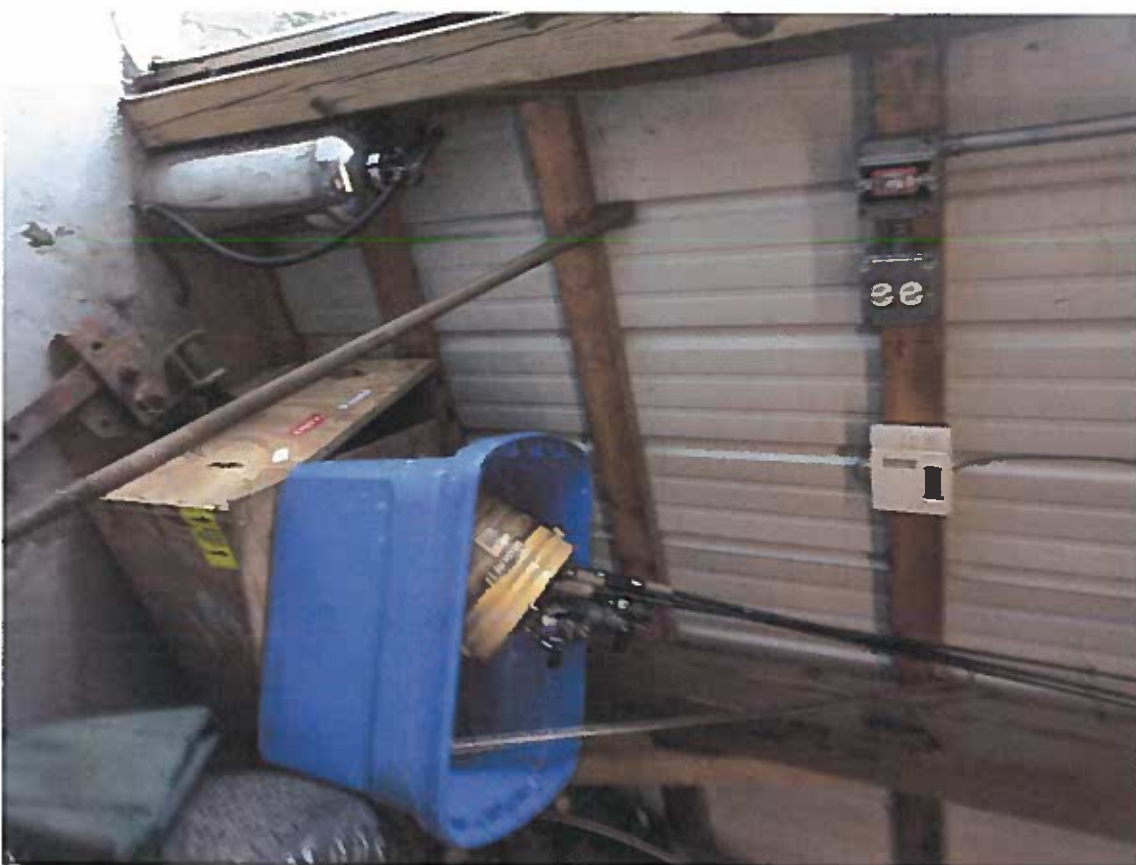
Missing light switch cover in rear white building. Old partially charged fire extinguisher.
